Professional Ropes Course Association (PRCA)

INDUSTRY ADVISORY Ground Anchors

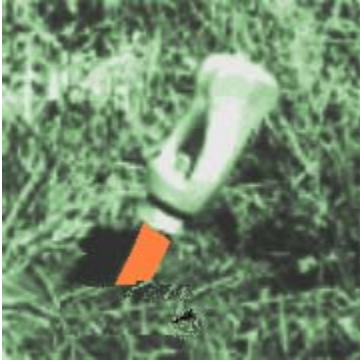
Marked Ground
Anchor

However, in order to identify potential anchor failures the PRCA recommends that all ground anchor rods be painted at the point where they contact the ground surface with high visibility paint. Thus if in the course of use the anchor begins to creep, "jack, heave or is shifting in a helix pocket beneath the ground it may be indicated by a simple visual inspection of the rod showing the unpainted surface below the paint line. This doesn't guarantee that you will always be aware of a problem but it is a good early warning system of common problems. Any indications of anchor creep should be reported to a qualified ropes course professional immediately for assessment and repair.

The use of high visibility paint also serves to help identify tripping hazards on your course. (See photos below)

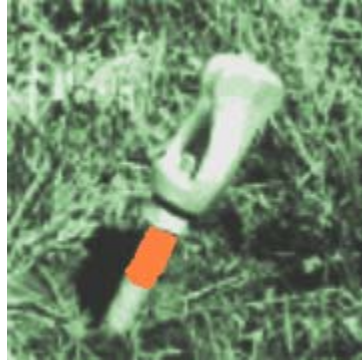
Marked Ground
Anchor showing
Creep

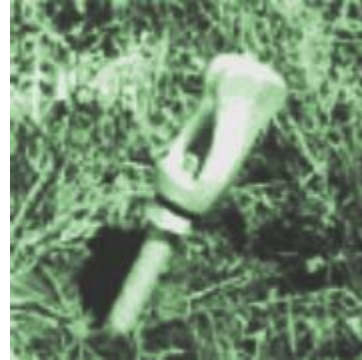
Unmarked
Ground Anchor
hiding Creep
